Loss Of Fresh Gas Flow Due To Malposition Of Vaporizer: An Oft Repeated Anaesthetic Misadventure

M Gupta, I Shri

M Gupta, I Shri. *Loss Of Fresh Gas Flow Due To Malposition Of Vaporizer: An Oft Repeated Anaesthetic Misadventure*. The Internet Journal of Anesthesiology. 2013 Volume 32 Number 2.

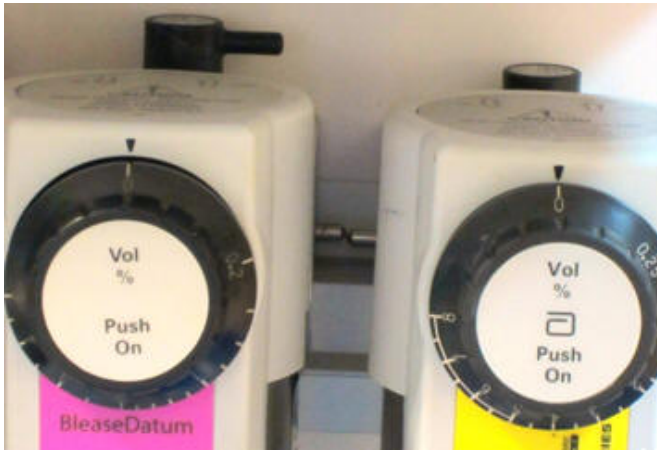
Figure 1

Mal-positioned Isoflurane vaporizer on to the vaporizer manifold (1-unlocked locking lever, 2-Non-aligned interlock pins)

Once it was repositioned and locked on the manifold, the test lung inflated. On retrospective analysis; failure to ventilate happened soon after the halothane vaporizer was replaced with the isoflurane vaporizer. On simulating the problem later, an audible quiet hiss, and a detectable odour was present at a close range from the vaporizer. There was no gas leak when no vaporizer were mounted on to the back bar and the vaporizer functioned well when used on another machine; thereby eliminating any error with in the vaporizer itself.

Once the vaporizer is correctly seated, lock the vaporizer into position by pushing down and turning the locking lever fully clockwise to the locked position. The weight of the vaporizer and O-ring around each port valve creates a seal between the mounting system and the vaporizer. A concentration control C regulates the gas flow through the vapour control valve P; the bypass valve R and vapour chamber to produce the required concentration. When the control is set to zero the bypass remains open, however the vapour chamber is completely isolated from the patient gas flow. When the control is set to the desired concentration; valve S opens allowing flow into the vapour chamber.¹¹

A low pressure circuit leak test should be performed daily; and each time the vaporizer is changed. ^{10, 15} If a check valve is present upstream a negative leak pressure test is advised which is performed by attaching a suction bulb at the outlet. Also for the self test to determine if an internal vaporizer leak is present; the leak test is repeated with each vaporizer sequentially while it's concentration control dial is in on position.¹⁵ This case highlights that human error and misuse of equipment is one of the causes of preventable anaesthetic misadventure. According to Cooper et al. human error was involved in 82% while, equipment failure in 14% of preventable incidents.¹⁶ Factors frequently associated are inadequate communication among personnel, haste or lack of precaution; and distraction,¹⁷ laziness, pride and boredom too ¹⁸ are responsible. Contributing factors to most of these errors are last minute changes because of change in schedule, breathing system, ventilator, or type of anaesthesia leading to a man- machine interaction failure.¹

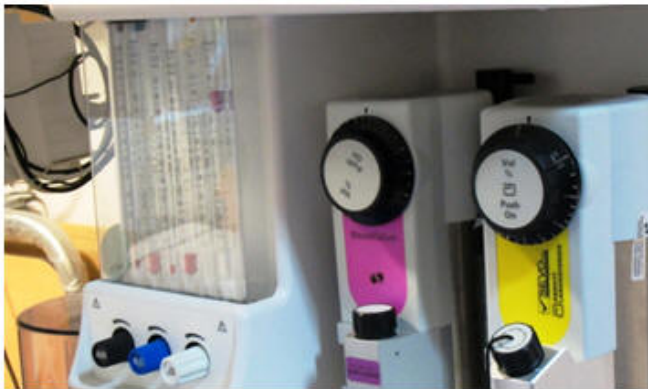
Figure 2

Concentration controlled dial open in Malpositioned vaporizer (1-Non-aligned interlock pins, 2-Open concentration controlled dial, 3- unlocked locking lever)

There are a few reported cases of anaesthetic vapor leakage from unlocked vaporizers. There was awareness and recall in two, 12, 13 while in one there was desaturation and hypercapnia.⁹ In our case and the case reported by Kim and Kim, ⁹ the concentration dial could be opened even when the vaporizer was not properly seated on the manifold; thereby not leading to an early recognition of the cause of the problem.

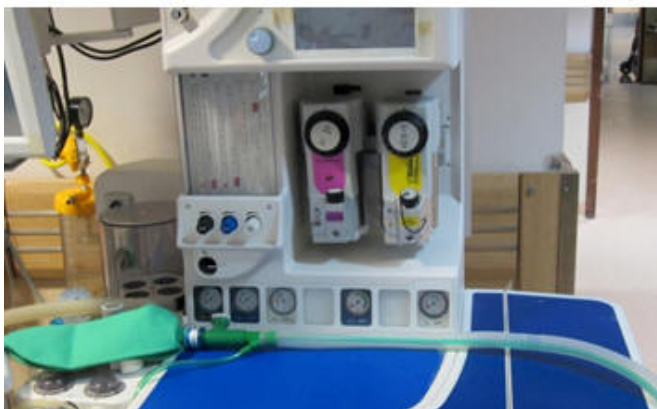
Figure 3

Although bobbins floating yet the reservoir bag collapsed, vaporizer in unlocked position

what happened in our case. It was probably a large leak resulting in no fresh gas flow at the outlet, leading to a quick attention towards the mishapening.
