Loss Of Fresh Gas Flow Due To Malposition Of Vaporizer: An Oft Repeated Anaesthetic Misadventure

M Gupta, I Shri

M Gupta, I Shri. *Loss Of Fresh Gas Flow Due To Malposition Of Vaporizer: An Oft Repeated Anaesthetic Misadventure*. The Internet Journal of Anesthesiology. 2013 Volume 32 Number 2.

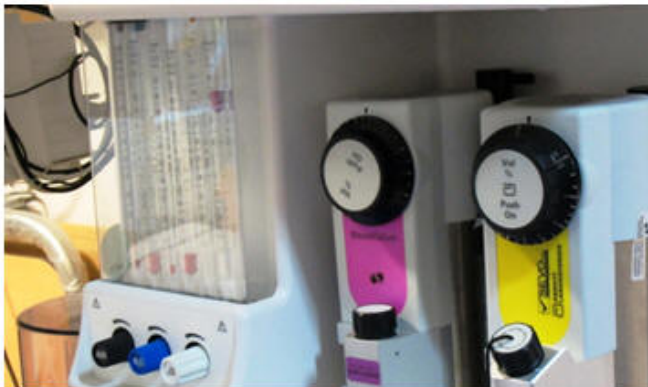
Figure 2

Concentration controlled dial open in Malpositioned vaporizer (1-Non-aligned interlock pins, 2-Open concentration controlled dial, 3- unlocked locking lever)

There are a few reported cases of anaesthetic vapor leakage from unlocked vaporizers. There was awareness and recall in two, 12, 13 while in one there was desaturation and hypercapnia.⁹ In our case and the case reported by Kim and Kim,⁹ the concentration dial could be opened even when the vaporizer was not properly seated on the manifold; thereby not leading to an early recognition of the cause of the problem.

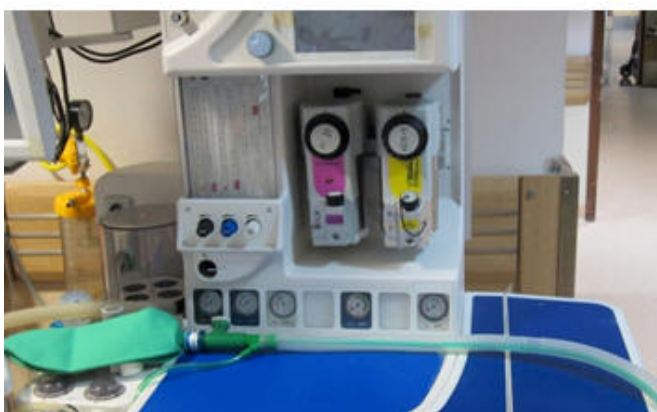
Figure 3

Although bobbins floating yet the reservoir bag collapsed, vaporizer in unlocked position

what happened in our case. It was probably a large leak resulting in no fresh gas flow at the outlet, leading to a quick attention towards the mishapening.

A low pressure circuit leak test should be performed daily; and each time the vaporizer is changed.^{10, 15} If a check valve is present upstream a negative leak pressure test is advised which is performed by attaching a suction bulb at the outlet. Also for the self test to determine if an internal vaporizer leak is present; the leak test is repeated with each vaporizer sequentially while it's concentration control dial is in on position.¹⁵ This case highlights that human error and misuse of equipment is one of the causes of preventable anaesthetic misadventure. According to Cooper et al. human error was involved in 82% while, equipment failure in 14% of preventable incidents.¹⁶ Factors frequently associated are inadequate communication among personnel, haste or lack of precaution; and distraction,¹⁷ laziness, pride and boredom too¹⁸ are responsible. Contributing factors to most of these errors are last minute changes because of change in schedule, breathing system, ventilator, or type of anaesthesia leading to a man- machine interaction failure.¹
