Loss Of Fresh Gas Flow Due To Malposition Of Vaporizer: An Oft Repeated Anaesthetic Misadventure

M Gupta, I Shri. *Loss Of Fresh Gas Flow Due To Malposition Of Vaporizer: An Oft Repeated Anaesthetic Misadventure*. The Internet Journal of Anesthesiology. 2013 Volume 32 Number 2.

We report a case of complete loss of fresh gas supply at anesthesia machine outlet due to malposition of vaporizer on to the manifold where it was lifted off and tilted up on one side. We also re-emphasize on the importance of strictly adhering to the recommendations for pre-use checks in the Anesthesia machine checklist, and by the manufacturers; and also for an effective collaboration amongst the operating room personnel.

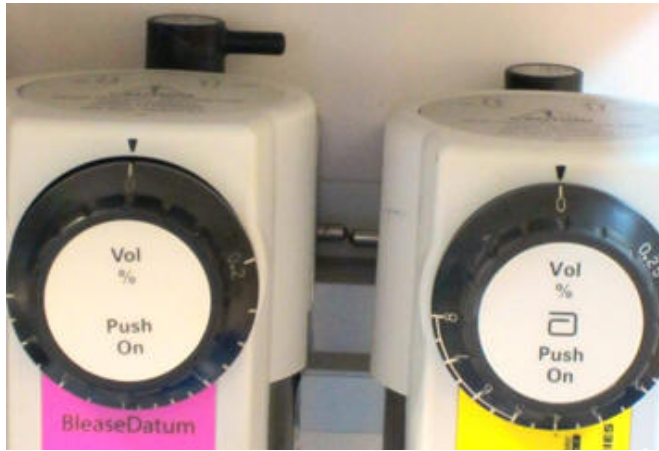
Figure 1

Mal-positioned Isoflurane vaporizer on to the vaporizer manifold (1-unlocked locking lever, 2-Non-aligned interlock pins)

Once the vaporizer is correctly seated, lock the vaporizer into position by pushing down and turning the locking lever fully clockwise to the locked position. The weight of the vaporizer and O-ring around each port valve creates a seal between the mounting system and the vaporizer. A concentration control C regulates the gas flow through the vapour control valve P; the bypass valve R and vapour chamber to produce the required concentration. When the control is set to zero the bypass remains open, however the vapour chamber is completely isolated from the patient gas flow. When the control is set to the desired concentration; valve S opens allowing flow into the vapour chamber.11

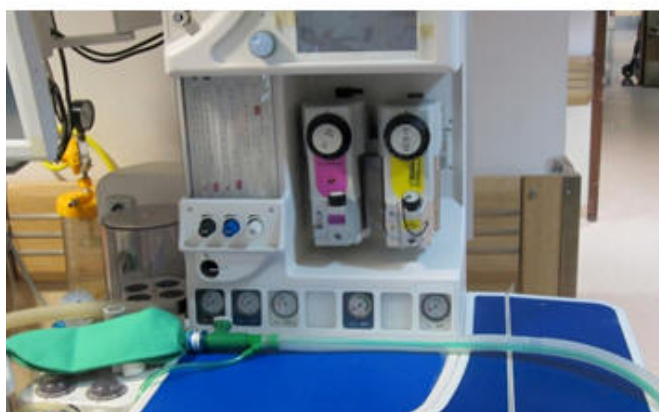
Figure 3

Although bobbins floating yet the reservoir bag collapsed, vaporizer in unlocked position

what happened in our case. It was probably a large leak resulting in no fresh gas flow at the outlet, leading to a quick attention towards the mishapening.

Once it was repositioned and locked on the manifold, the test lung inflated. On retrospective analysis; failure to ventilate happened soon after the halothane vaporizer was replaced with the isoflurane vaporizer. On simulating the problem later, an audible quiet hiss, and a detectable odour was present at a close range from the vaporizer. There was no gas leak when no vaporizer were mounted on to the back bar and the vaporizer functioned well when used on another machine; thereby eliminating any error with in the vaporizer itself.
