Seven Years of Left Ventricle Pacing Due to Malpositioning Through Patent Foramen Ovale.

A Sharma, E Heist, J Horowitz, M Baig. Seven Years of Left Ventricle Pacing Due to Mal-positioning Through Patent Foramen Ovale .. The Internet Journal of Cardiology. 2009 Volume 9 Number 1.

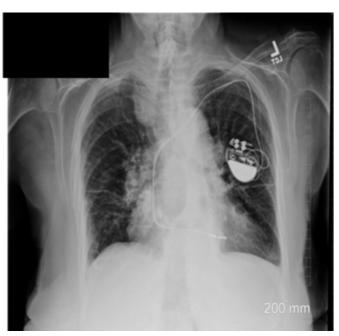
Initial EKG on presentation showed a RBBB pattern (Fig. 1). Chest radiography demonstrated a posterior displacement of the ventricular lead, suggestive of placement in the LV rather than the RV (Fig. 2a and 2b). A transthoracic echocardiogram (TTE) demonstrated an ejection fraction of 55-60% with impaired LV relaxation and reversal of mitral E-A wave ratio. There was mild to moderate tricuspid regurgitation with a right ventricular systolic pressure of 51 mm Hg with an estimated RA pressure of 10 mm Hg. The ventricular pacing lead was noted to cross the inter-atrial septum with implantation into the left ventricle(Fig. 3). A

Fig. 2(a) PA view of chest X Ray

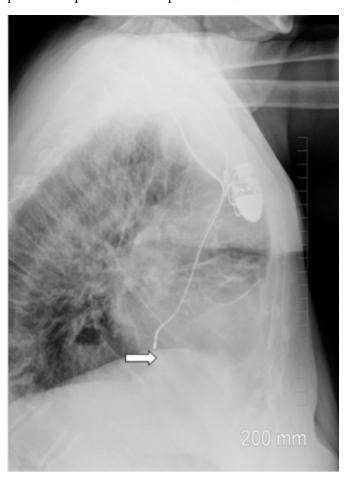
Fig. 2(b) Lateral view of CXR - Arrow pointing to the posterior displacement of the pacemaker wire.

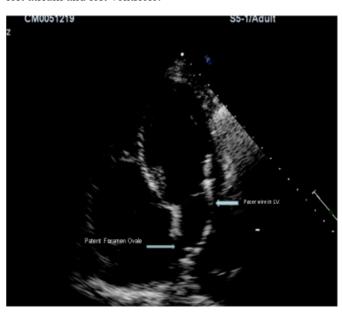
Fig. 3 – Four chamber view of ECHO showing patent foramen ovale and the pacer wire passing through it into the left atrium and left ventricle.

Cardiology consultation recommended consideration of long term anti-coagulation with warfarin as these patients are considered high risk of having a thromboembolic event. After consideration the patient declined long term anticoagulation. She felt that due to her advanced age and lack of any symptoms, the added risk of anticoagulation was too high. The patient was treated for her congestive heart failure and discharged home after an uneventful hospitalization.

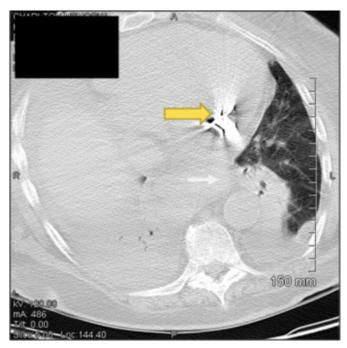
CT scan of the chest also showed the ventricular pacing lead within the LV (Fig.4). The patient had had no documented thromboembolic events.

Fig. 4 – CT Chest – Arrow pointing towards the diffraction from the pacemaker wire in the left ventricle.
