# Restoration Of A Fractured Tooth With Dental Glass Fiber And Composite Crown: A Case Report

B Bagis, R Durkan. *Restoration Of A Fractured Tooth With Dental Glass Fiber And Composite Crown: A Case Report*. The Internet Journal of Dental Science. 2006 Volume 5 Number 2.

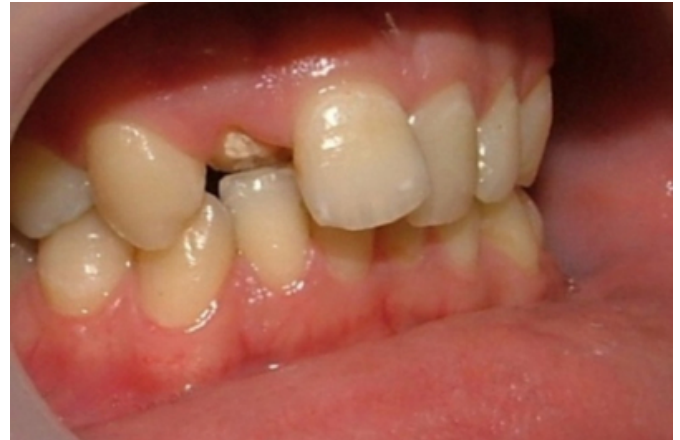
**Figure 1**

Figure 1: Clinical situation of a 18-year-old patient whose maxillary lateral incisor was fractured

An 28-year-old male patient was initially examined for acute pain in the maxillary right lateral incisor. Clinical examination revealed that her maxillary right lateral incisor tooth was fractured at the cemento-enamel junction. The root of the tooth was treated endodontically and filled with gutta percha and resin sealer in the normal manner, followed by gingivectomy in the labial region (Fig. 1). Afterward, the gutta percha was removed with Gates drills (Antaeos, VDW GmbH, Munchen, Germany) without enlarging the canal. At least 3–5 mm of gutta percha was left at the apex of the root. The depth of the prepared canal was measured using a periodontal probe, and the root canal drilled according to general principles until it measured the estimated depth required for the post. The inside of the root was rinsed and dried carefully, and the working area was isolated from moisture by cotton plugs.

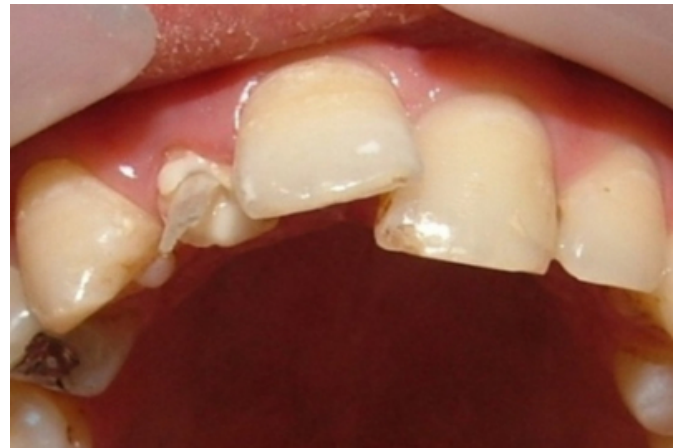
**Figure 2**

Figure 2: Fiber post adjusted and luted

A dual-resin cement (Rely X Unicem, 3M ESPE, Seefeld, Germany) was used as a luting agent for the glass fiber post. The cement was applied with a lentulo spiral into the post space, and the post was inserted into the canal (Fig. 2). Excess resin cement was removed with a clean microbrush and the cement was light cured for 40 seconds. The restorative procedure was completed by building up the tooth incrementally with a direct resin composite restoration (Gradia Direct, GC Corporation, Tokyo, Japan) of an appropriate shade (Fig. 3a,3b). The occlusion was carefully adjusted to avoid any primary contacts or traumatic occlusal forces to the restored tooth. Finally, the composite resin crown restoration was polished with a composite polishing kit (Soflex, 3M ESPE, St Paul, MN, USA) (Fig. 4).

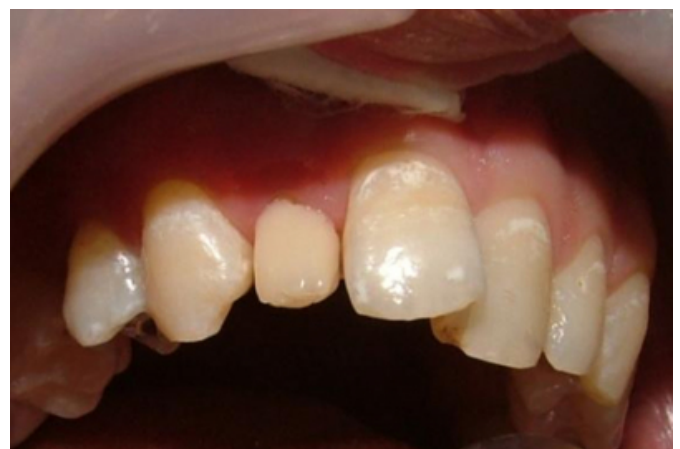
**Figure 3**

Figure 3a: Composite build up

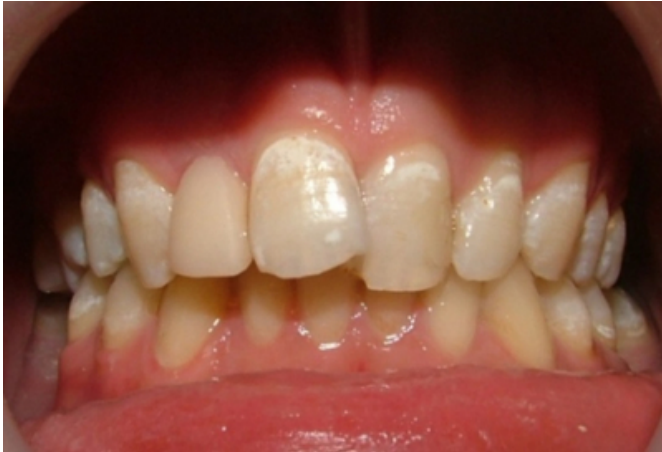
**Figure 4**

Figure 3b: Composite crown

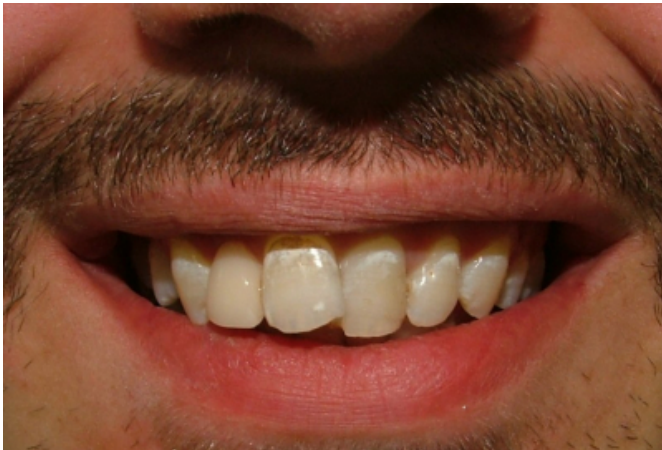
**Figure 5**

Figure 4: Postoperative clinical result

The patient was recalled at three months for clinical evaluation of the restored tooth. During the recall appointment, an assessment of the stability and longevity of the restoration was performed. Color stability, surface staining, and retention due to fracture of the post or fracture of the composite build-up material were evaluated and found to be acceptable. The patient had no complaints about the restoration.
