# High Failure Rates Of A Hybrid Large-Diameter Head Metal-On-Metal Total Hip Replacement: A Case Series Of Fifteen Patients

B Akinola, C Lawrence, M Weston, R Rodrigues, S Bhargava, A MacDowell

B Akinola, C Lawrence, M Weston, R Rodrigues, S Bhargava, A MacDowell. *High Failure Rates Of A Hybrid Large-Diameter Head Metal-On-Metal Total Hip Replacement: A Case Series Of Fifteen Patients*. The Internet Journal of Orthopedic Surgery. 2014 Volume 22 Number 1.

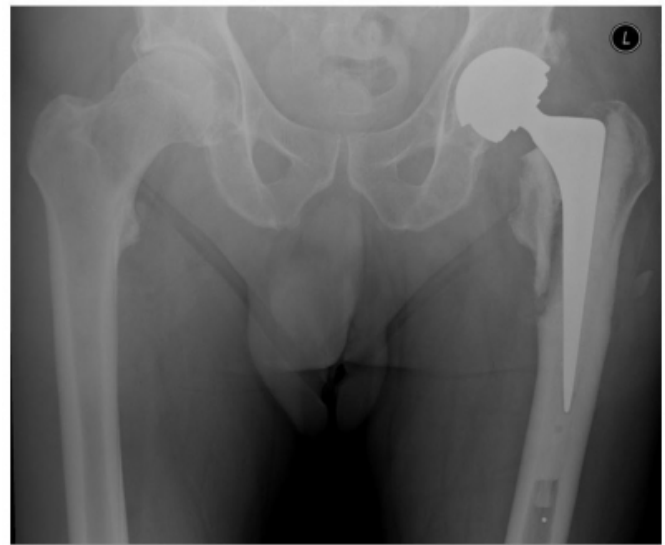
Figure 1

Radiological analysis. Features of failure include periprosthetic fracture (Figure 1), bone resorption in the medial calcar region with progressive lucency in Gruen zone 1 (Figure 2), and stem subsidence (Figure 3). In each case of failure identified, the radiographic changes were of failure of the femoral component. The Durom acetabular shell in each case appeared radiologically stable with no signs of loosening. Magnetic resonance imaging (MRI) scans were performed on most patients.

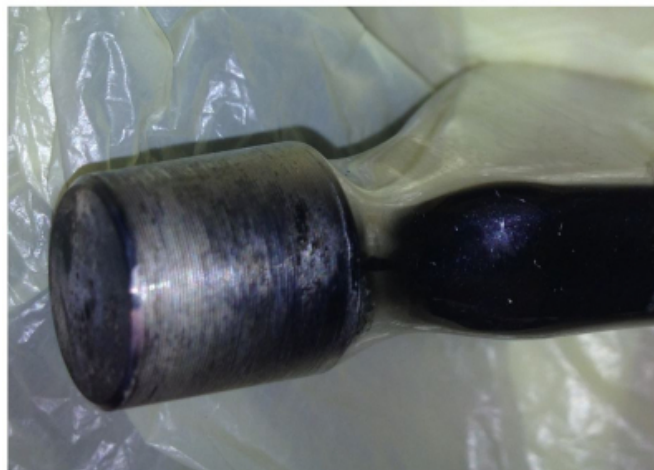
**Figure 6**

On removal of the femoral head, black markings were macroscopically visible at the trunnion / modular head interface (Figure 6) with evidence of eccentric wear of the trunnion and reciprocal wear on the sleeve of the head adaptor. The stem had evidence of black staining on its surface, as well as evidence of corrosion along its length (Figure 7). In some cases, black staining of the cement mantle was noted. In several cases, there was fragmentation of the cement with caseous tissue in the cement / bone interface, particularly at the greater trochanteric region.

Retrieval analysis of a similar hybrid system to ours has identified the trunnion-head interface as a potential source of metal ion debris and suggested a mechanical cause from excess force at the interface [10]. The presence of a large head on a 12/14 taper could be to blame for this excessive force. It has been reported that when metal is tested on polyethylene, torsional forces at the trunnion increase as the head size increases [13]. Macroscopic evaluation of the trunnions of all the explanted femoral stems in our series also demonstrated evidence of abnormal wear with reciprocal changes in the femoral part of the sleeve component. In their series, Bolland et al [10] identified pain as a prominent feature of failure, accompanied by radiological abnormalities. This appears to be the case in our series as well although the pain was so mild that it did not warrant the use of regular analgesia or the need for medical consultation. There is a growing concern that some patients may be in the community, relatively satisfied with the function of their arthroplasty, but harbouring a potentially very serious problem with their hip. Indeed 2 of our patients had catastrophic failure of their femoral component with displaced periprosthetic fracture, yet were unaware and were not intending to seek medical review until contacted by our department.
