Beware: Non-prosthetic plastic in cemented arthroplasty

A Hussain, K Prasad, S Kumar. *Beware: Non-prosthetic plastic in cemented arthroplasty*. The Internet Journal of Orthopedic Surgery. 2006 Volume 7 Number 2.

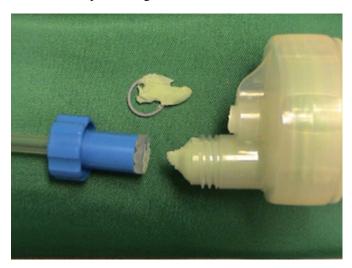
Figure 1a: Photograph of OPTIVAC Cement Mixing System with detached plastic ring.

Recently, while cementing the tibial surface during total knee replacement in a 71-year old lady, we noticed a ring-shaped bluish tinge in the cement. To our surprise, we retrieved a plastic ring from the cement, which detached from the Cement Mixing and Delivery System (Fig 1a and 1b).

We recommend that all members of the operating team and scrub nurse should be acutely aware of the risk and remain alert to pre-empt accidental deposition of non-prosthetic plastic in cemented arthroplasty. The potential for unpredictable and accelerated diversity of qualitative and volumetric wear, local osteolysis and component failure₃ is daunting. Surgeon and nurse education, training and

alertness minimise the risk, but the definitive solution is the development and use of a cement mixing and delivery system without any loose plastic component at any stage.
