Surgical Removal of a Retained Glass Foreign Body Using Point of Care Ultrasonography

M Greenberg, A Brzenski, E Hentzen

M Greenberg, A Brzenski, E Hentzen. *Surgical Removal of a Retained Glass Foreign Body Using Point of Care Ultrasonography*. The Internet Journal of Hand Surgery. 2021 Volume 10 Number 1.

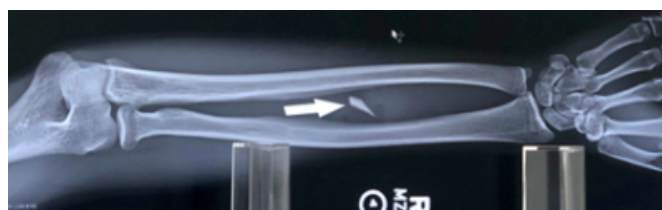
Figure 1

Radiograph of right forearm. Foreign body seen in the center of the image (white arrow)

A 20-year-old female incurred a 2.5 cm deep laceration to the volar aspect of the right forearm. The injury occurred when she punched through a glass window. She was seen in the emergency department immediately following the injury where radiographs of the forearm revealed a shard of glass retained in the area of the wound (Figure 1).

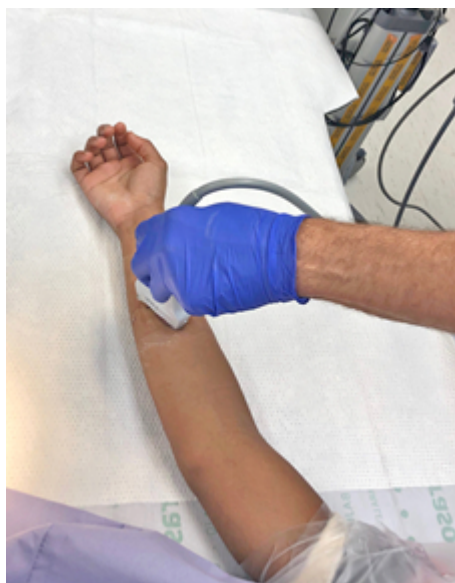
Figure 2

The ultrasound examination was accomplished using a 13- to 6-MHz 38-mm linear array ultrasound transducer (Edge II; SonoSite, Bothell, WA)

anesthesia and operative time, the OR team decided to use point-of-care ultrasound to which was readily available in the OR suite (Figure 2). The ultrasound examination was accomplished using a 13- to 6-MHz 38-mm linear array ultrasound transducer (Edge II; SonoSite, Bothell, WA) to scan the forearm. After scanning in multiple planes, the FB was easily imaged and its location was precisely marked in the overlying skin (Figure 3). The FB's relationship to other critical structures was examined and it was found not to be near a major nerve, or blood vessel.

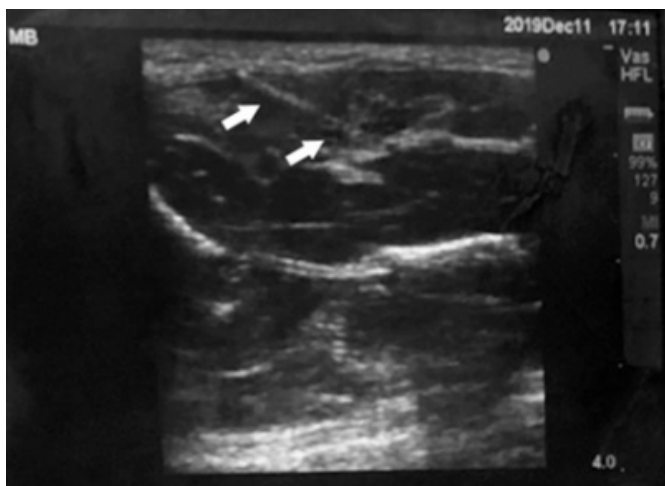
Figure 3

Ultrasound image of the foreign body (white arrows)

efficient removal. In our patient, US examination revealed more information than just where to make the incision. Imaging also revealed the orientation and depth of the mass and that it was relatively distant from critical neural and vascular structures. Although not used during the operation in our patient, US can be used in real time for difficult to remove FB or for those which are located adjacent to critical structures.
