# Restoration Of A Severely Damaged Crown With Chopped Glass Fibers And Core Build-Ups : A Clinical Report

R Durkan, E Ayaz. *Restoration Of A Severely Damaged Crown With Chopped Glass Fibers And Core Build-Ups : A Clinical Report*. The Internet Journal of Dental Science. 2010 Volume 10 Number 1.

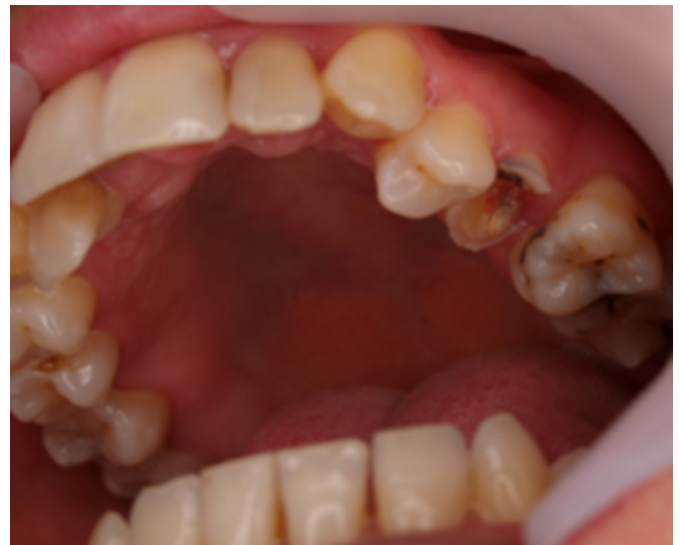
**Figure 1**

Our patient was a 42-year-old woman with a noncontributory medical history. She had an excessively damaged premolar tooth (tooth 25). The root canals were filled with vertically condensed warm gutta-percha (Guttapercha Points, Dentsply DeTrey, Konstanz, Germany) and endodontic resin sealer. Two weeks after endodontic

Figure 1 Intraoral view of the damaged crown before treatment

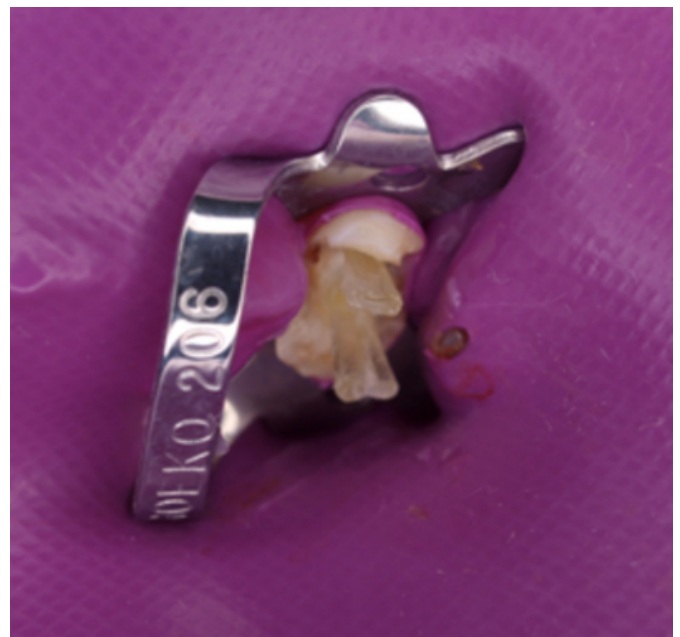
**Figure 2**

Figure 2 Glass fiber posts in the root canals

treatment, roots were prepared for post placement. Rubber dam was used to avoid the area from moisture for adhesive procedures. Root canal space was prepared with Gates drills (Antaeos, VDW GmbH, Munchen, Germany), to length of 8–9 mm; at least 3–4 mm of apical seal was maintained. The length of the glass fiber-reinforced post (Everstick, Turku, Finland) was measured using endodontic files. The root canal was rinsed and dried with sterile paper points (Absorbent Paper Points, Dentsply DeTrey, Konstanz, Germany). Etching gel 37% phosphoric acid (3M ESPE, St Paul, MN, USA) was applied to the post space for 15 s and rinsed off with water using an endodontic syringe then dried with sterile paper points. A single coat of dual-cure adhesive system (Single Bond 2, 3M ESPE, St Paul, MN, USA) was applied following the manufacturer's instruction using Microbrush fine (Microbrush International, Grafton, USA) and then cured with LED light source of 1000 mW/cm<sup>2</sup> intensity (Elipar Free Light 2, 3M ESPE, St. Paul, MN, USA) for 10 seconds. Fiber post was wetted with bonding resin, then cemented with dual cure resin cement. To fit with the diameter of the canal, an Ever Stick Post (Stick Tech Ltd, Turku, Finland) with a diameter of 0.9 mm was used. A dual-cure composite resin cement (Rely X-ARC; 3M ESPE, Seefeld, Germany) was applied to the post space with a Lentulo spiral (Dentsply Maillefer, Ballaigues, Switzerland) and on the post surface and then the post was seated. After removing excess cement, the correct position of the post was verified and the resin was light-cured for 20 seconds. For the purpose of the reconstruction of the coronal tooth structure, core build-up was performed using matrix directly over the fiber post with chopped 4 mm length glass fibers.

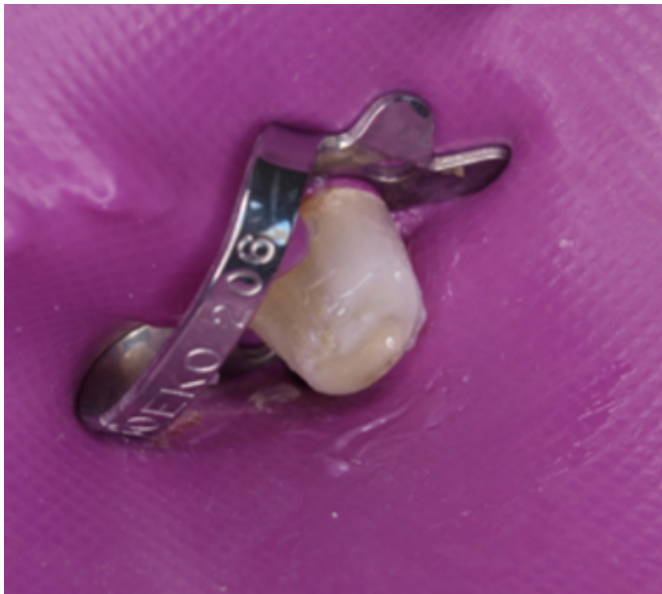
**Figure 3**

Figure 3 Core structure by chopped fiber bundles and core form

Core structure was shaped with chopped glass fiber bundles and flowable composite (Flowable Stick Tech Ltd, Turku, Finland) by using a core form (Clearfil Core Form, Kuraray Medical Inc., Okayama, Japan). Core form materials provide fast and easy manipulation. Light was positioned above the core for 40 seconds on each side. After tooth preparation with diamond burs, final restoration was finished with full ceramic zirconia crown. Zirconia ceramic crown was bonded to composite resin core with a resin luting agent containing a phosphate monomer (Panavia F, Kuraray) according to the manufacturers instructions. Excess resin was removed with a help of brush. The luting agent was polymerised for 40 seconds on each side of bonding area.

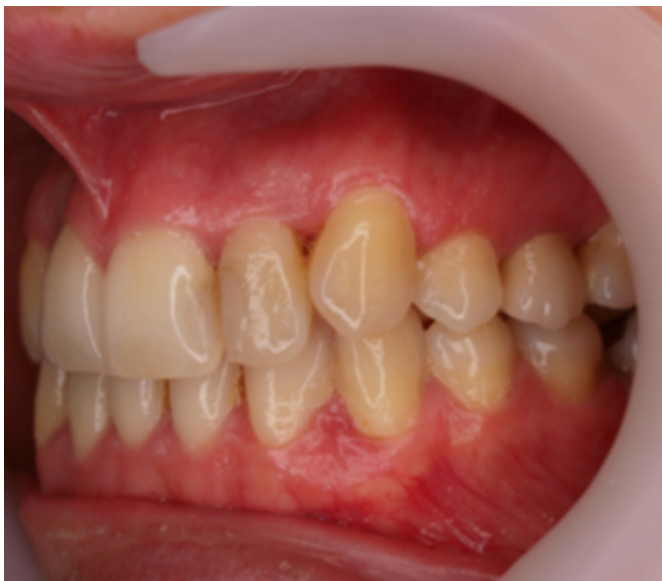
**Figure 4**

Figure 4 Intraoral view of the final all ceramic restoration

During the recall appointment, an assessment of the stability and longevity of the restoration was also performed. Color stability, surface staining, and retention due to fracture of the post or fracture of the glass fibers build-up restoration was evaluated and found to be acceptable. It was found out following the study that the patient had no complaints about the restorations.
