Bus Accident In Zuerich-Switzerland

O Wenker, A Meyer

O Wenker, A Meyer. *Bus Accident In Zuerich-Switzerland*. The Internet Journal of Rescue and Disaster Medicine. 1997 Volume 1 Number 1.

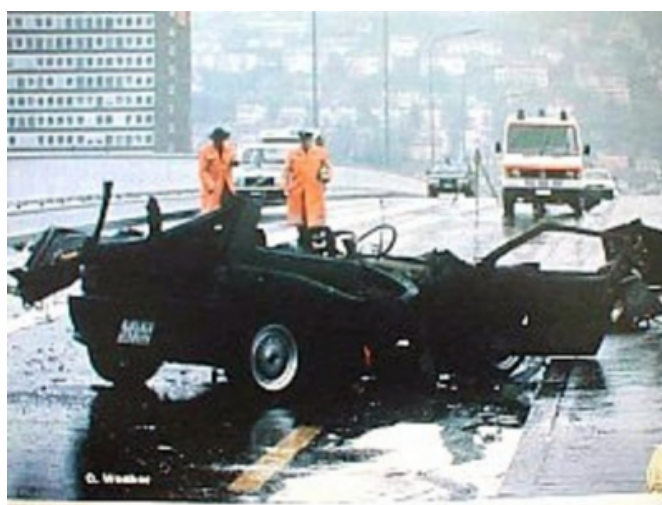
Figure 1

Severely damaged Fiat Uno

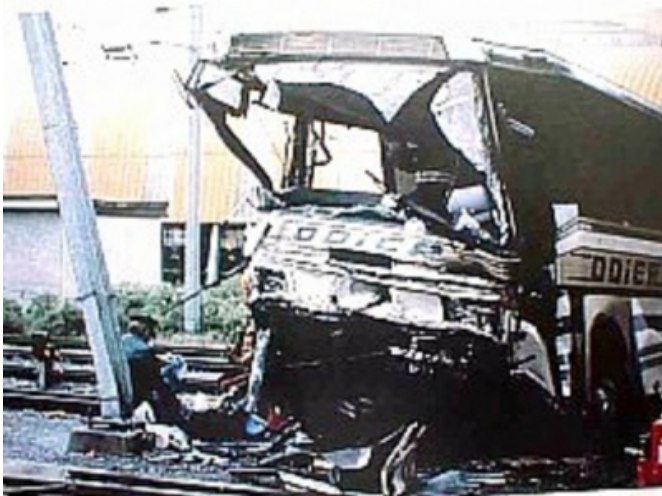
Figure 7

Front view of the damaged bus and the power pole on the left

A significant part of the victims suffered from chest and back injuries such as rib fractures, hemothorax, lung contusion, sternum fracture, cardiac contusion, thoracic and lumbar vertebrae fractures. While the bus was falling off the bridge all passengers were elevated from their seats and when the bus landed on the front wheels they were hurled against the back of the seats in front of them. Many of the passengers smashed with their chests against the upper edge of the seats in front of them. 3 patients were trapped in their seats and had to be freed by specially equipped firefighters.

- the bus hit a power pole
- the bus landed on his wheels and did not overturn
- the power cables did not represent a danger
- no train was running on the tracks at the moment of the accident
- the location of the accident was easy accessible
- traffic was light and a variety of hospitals were nearby
