# Restoration Of A Fractured Tooth With Dental Glass Fiber And Composite Crown: A Case Report

B Bagis, R Durkan. *Restoration Of A Fractured Tooth With Dental Glass Fiber And Composite Crown: A Case Report*. The Internet Journal of Dental Science. 2006 Volume 5 Number 2.

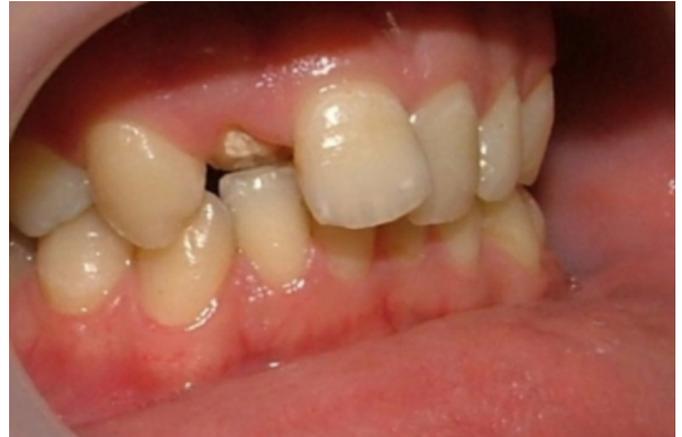
**Figure 1**

An 28-year-old male patient was initially examined for acute pain in the maxillary right lateral incisor. Clinical examination revealed that her maxillary right lateral incisor tooth was fractured at the cemento-enamel junction. The root of the tooth was treated endodontically and filled with gutta percha and resin sealer in the normal manner, followed by gingivectomy in the labial region (Fig. 1). Afterward, the gutta percha was removed with Gates drills (Antaeos, VDW GmbH, Munchen, Germany) without enlarging the canal. At least 3–5 mm of gutta percha was left at the apex of the root. The depth of the prepared canal was measured using a periodontal probe, and the root canal drilled according to general principles until it measured the estimated depth required for the post. The inside of the root was rinsed and dried carefully, and the working area was isolated from moisture by cotton plugs.

Figure 1: Clinical situation of a 18-year-old patient whose maxillary lateral incisor was fractured

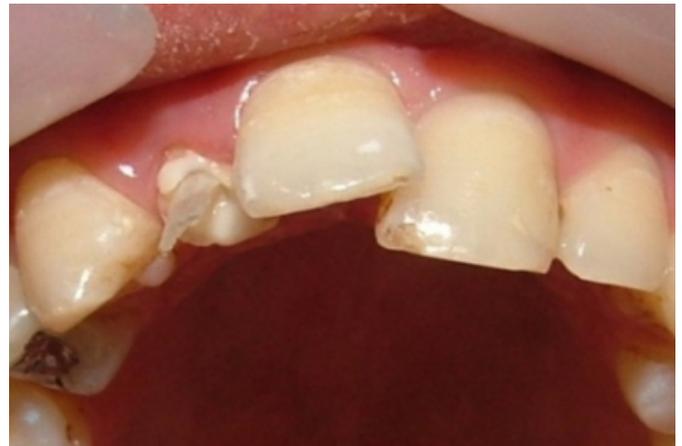
**Figure 2**

Figure 2: Fiber post adjusted and luted

A dual-resin cement (Rely X Unicem, 3M ESPE, Seefeld, Germany) was used as a luting agent for the glass fiber post. The cement was applied with a lentulo spiral into the post space, and the post was inserted into the canal (Fig. 2). Excess resin cement was removed with a clean microbrush and the cement was light cured for 40 seconds. The restorative procedure was completed by building up the tooth incrementally with a direct resin composite restoration (Gradia Direct, GC Corporation, Tokyo, Japan) of an appropriate shade (Fig. 3a,3b). The occlusion was carefully adjusted to avoid any primary contacts or traumatic occlusal forces to the restored tooth. Finally, the composite resin crown restoration was polished with a composite polishing kit (Soflex, 3M ESPE, St Paul, MN, USA) (Fig. 4).

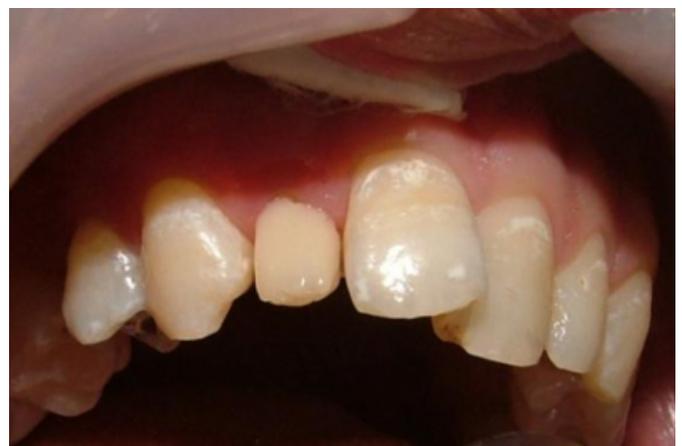
**Figure 3**

Figure 3a: Composite build up

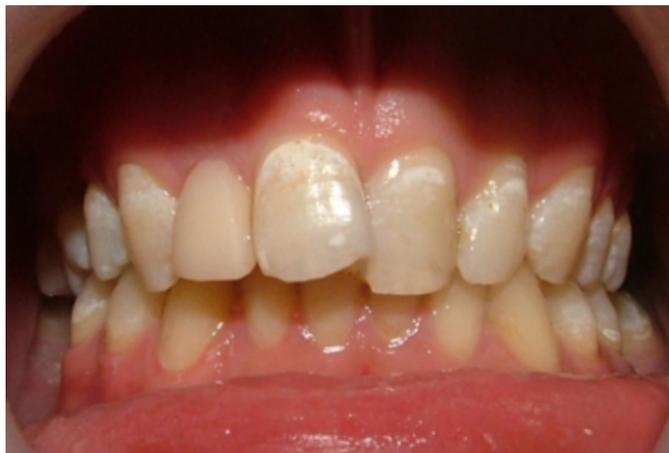
**Figure 4**

Figure 3b: Composite crown

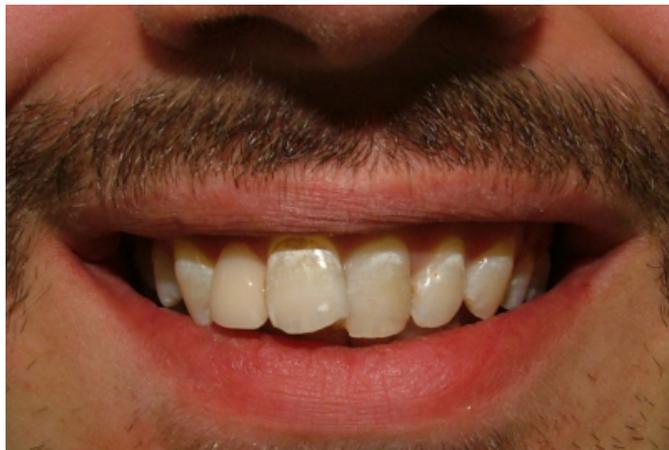
**Figure 5**

The patient was recalled at three months for clinical evaluation of the restored tooth. During the recall appointment, an assessment of the stability and longevity of the restoration was performed. Color stability, surface staining, and retention due to fracture of the post or fracture of the composite build-up material were evaluated and found to be acceptable. The patient had no complaints about the restoration.

Figure 4: Postoperative clinical result
