Fracture of an Exeter stem-a case report

B Akinola, T Mahmud, N DeRoeck

B Akinola, T Mahmud, N DeRoeck. *Fracture of an Exeter stem-a case report*. The Internet Journal of Orthopedic Surgery. 2009 Volume 16 Number 1.

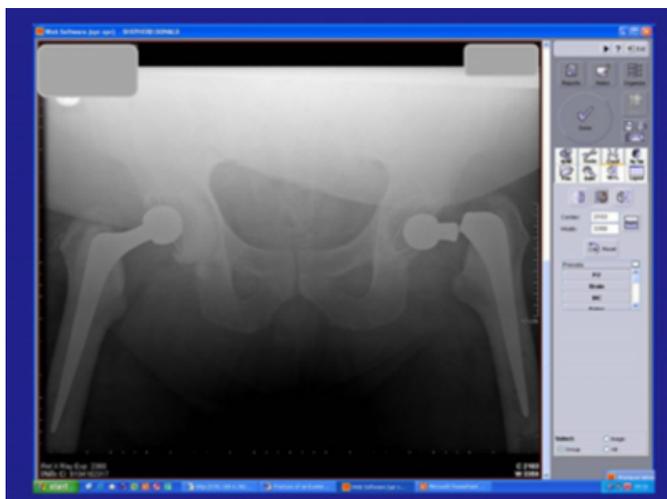
Figure 1

A 68 year old gentleman who weighed 121 kilograms, and who had previously undergone bilateral cemented Exeter total hip arthroplasty, presented to the emergency department at our hospital following a simple mechanical fall from a standing height. On presentation he complained of pain in his left groin and proximal thigh and had a short and externally rotated left lower limb. Plain radiographs of the pelvis revealed a fracture of the left Exeter femoral prosthesis at the neck-shaft junction. The cement mantle in the femur and acetabular component appeared to be intact (Figures 1 & 2). The patient subsequently underwent revision surgery.

At the time of surgery the acetabular component showed no signs of wear and was well fixed. The fractured stem was removed and examined. The femoral cement mantle was intact. A cement-in-cement revision was subsequently carried out using an Exeter short femoral revision stem with a 44 mm offset (Figure 3). The patient went on to make a good post-operative recovery.
