Tropical Storm Allison Recovery: A Facilities And Operations Perspective

M Hatton. *Tropical Storm Allison Recovery: A Facilities And Operations Perspective*. The Internet Journal of Rescue and Disaster Medicine. 2001 Volume 3 Number 1.

The Texas Medical Center was devastated by Tropical Storm Allison on June 8th and 9th, 2001 resulting in diminished operational services for several key healthcare facilities in the Houston community. Memorial Hermann Hospital and Memorial Hermann Children's Hospital experienced severe flooding to two lower levels of the facility and the resultant loss of key utility systems necessitated a systematic evacuation of the patient population. The Hermann facility was closed to patient care for a period of 38 days while operational systems were restored and the facility re-certified for health-care operations. Key to the disaster was the unprecedented storm event (estimated at a frequency greater than a 100-year event) (1), changes in watershed development patterns, and the location of key utility systems below-grade in many facilities. Master planning efforts are currently in progress to add system redundancies, improve preparedness for future utility

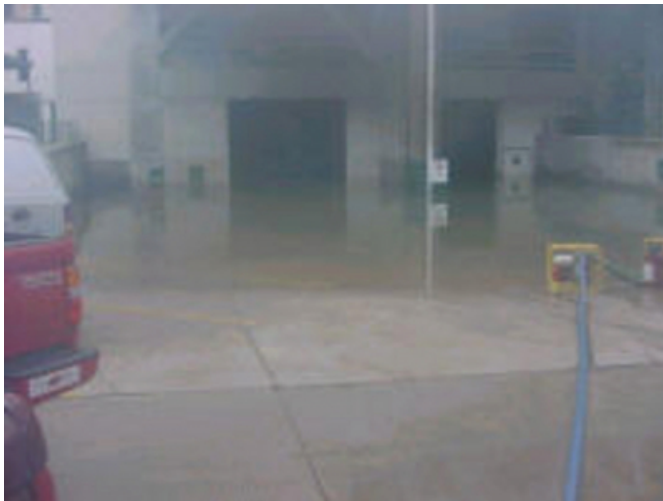
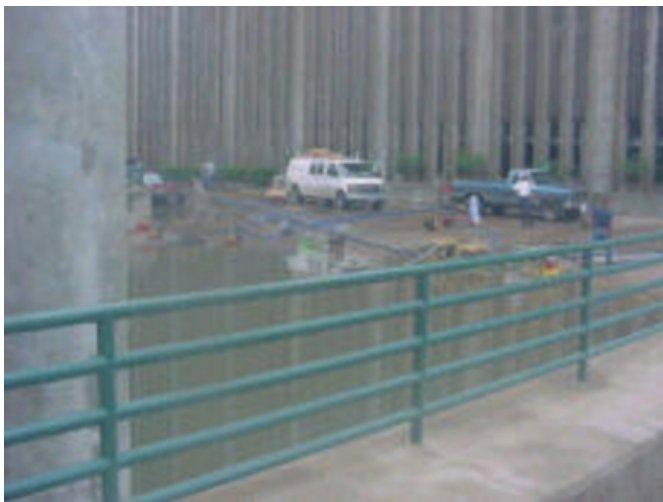
Key to the recovery process was removal of the floodwaters from the two lower levels and connecting tunnels of the campus. It is estimated that Hermann had been inundated with over 42 million gallons of water and water depths reached levels of 38 feet in two of the Pavilions. Thus, the water had to be removed before even a preliminary assessment of the damage could occur. Resources utilized

for this task included oil field pumping equipment, large construction pumps and specialty pumps from the merchant marine industry. Note that this specialty equipment is not typically found in emergency preparedness supply depots. Also, due to great horizontal distances in a facility of this magnitude final pumping operations of remote stairwells, elevator shafts, and utility tunnels were accomplished by positive displacement pumps and vacuum trucks, as normal centrifugal pumps were limited in lift capabilities.

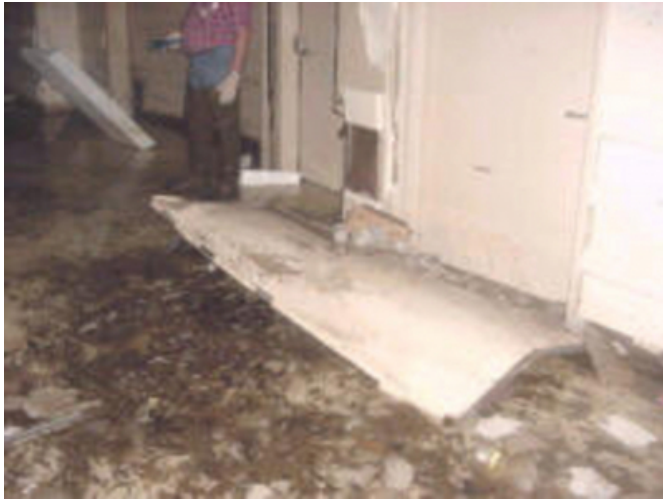
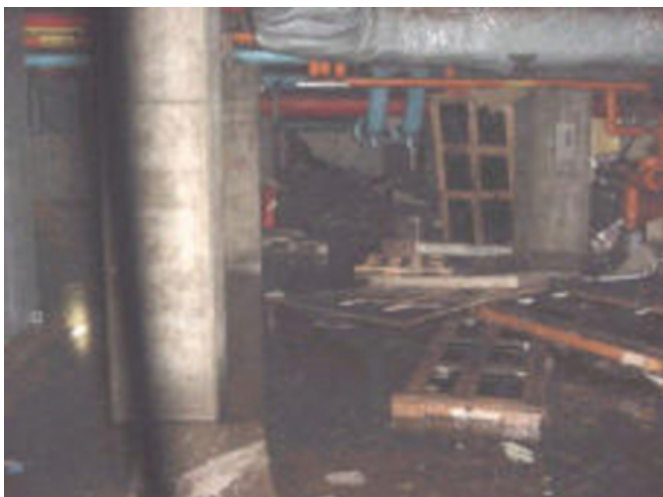
Key to the recovery process were both short-term demolition activities and initiating a Master Planning effort to assist with decision making for the reconstruction phase of the project. Early in the recovery phase a key decision was made

to demolish any flooded areas back to the concrete slab and as such minimize future issues with infection control and indoor air quality.

Although very controversial with insurance carriers, this decision proved beneficial to the recovery process as it clarified scope of work and simplified planning for re-building key features necessary for occupancy. Overall, 650,000 square feet of flood-damaged real estate was demolished at the Hermann complex within the first two weeks of the recovery process.

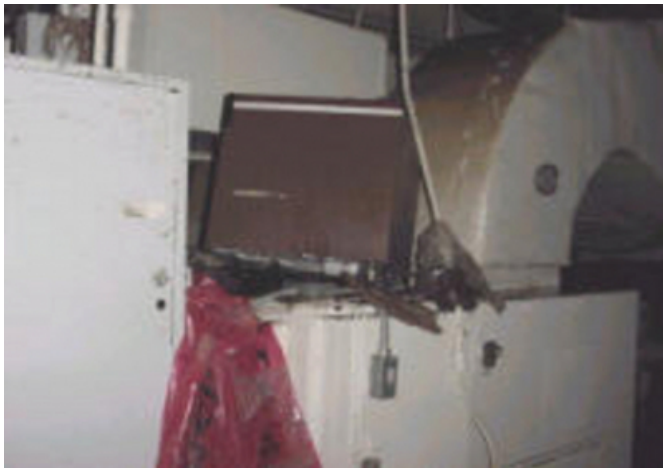
Figure 10

One operational issue that continued to hinder the recovery process was hazardous waste originating from the basement level Pathology Lab. This laboratory occupied 40,000 square feet immediately adjacent to both key utility service entrances and floodwater entry points. As such, the force of the water distributed hazardous waste over the entire basement level of the complex – some 110,000 square feet of real estate. Local resources that are typically utilized in disposing of hazardous materials were soon overburdened with the magnitude of the disaster and as such, planning and clean-up activities required support from as far away as Oregon, Illinois, and Virginia.

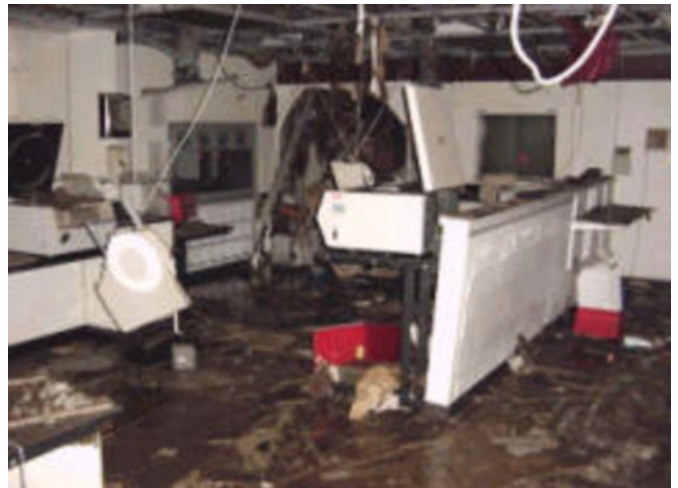
Figure 11

Flooded areas were separated from undamaged sections of the facility utilizing containment practices similar to those in the asbestos abatement industry. The goal was to isolate patient care areas both horizontally (at ground level) and vertically (elevator shafts and stairwells) to minimize the impact of environmental contamination.

Biocides were continually applied to the damaged lower levels to control microorganisms and facilitate cleanup.

Temporary heating, ventilation, and air conditioning (HVAC) systems were installed in key locations to minimize contamination, dehumidify flooded areas, and maintain negative pressure relationships in flood damaged spaces. Over 2000 tons of temporary chillers were installed during the first week of the recovery phase – many of which continued in operation for the remainder of the summer season.
