Complication Of Venous Cut-Down: Migration Of Catheter That Remained In The Vein

M Edis, T Ege, E Duran. *Complication Of Venous Cut-Down: Migration Of Catheter That Remained In The Vein*. The Internet Journal of Emergency Medicine. 2004 Volume 2 Number 2.

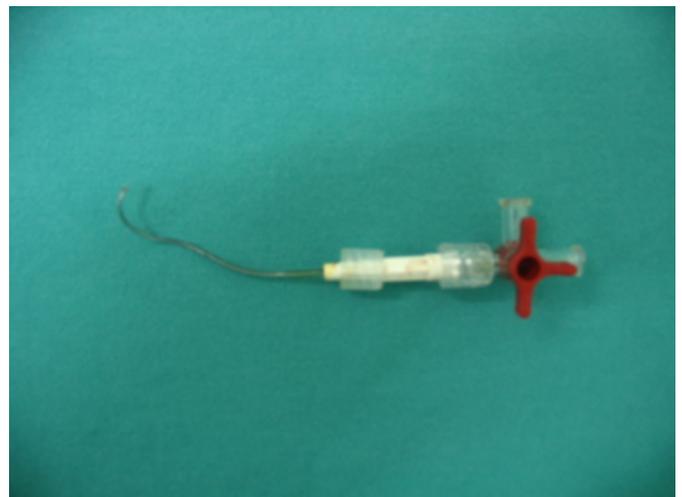
Figure 1

32 years old male patient was brought to the emergency service with a severe complaint of serious dyspnea and we detected that the patient had ALS diagnosis twelve years ago, he was bed-dependent and could not swallow for three years. After his hospitalization, central catheterization had been used with the cephalic vein cut-down technique on his left arm for the medical therapy. Just before the completion of the treatment of the patient, the catheter had broken off and the large part of it had remained in the venous system of him. As a result, we were required to consultate the patient

Picture 1: A outside part of Cava-fix catheter after it is broken down

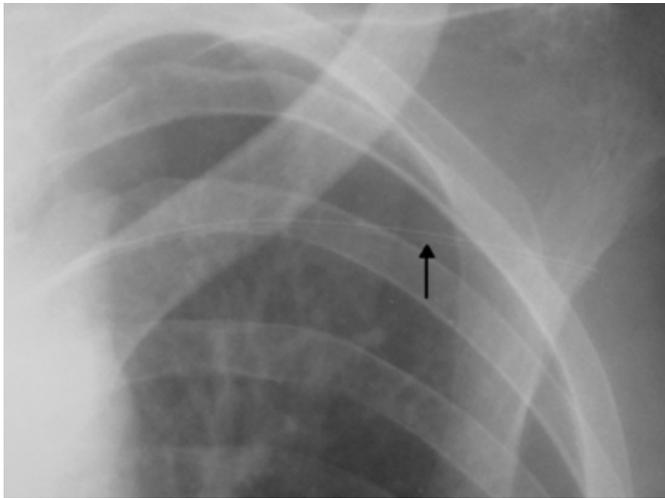
Figure 2

During his first physical examination, the patient was conscious, cooperative, and quadriplegic. He had also taken mechanical ventilator treatment via tracheostomy. There was an insertion area of venous cannula with the antecubital cut-down incision on the left arm. With an immediate anteroposterior chest graphy, it was detected that the catheter was lying from antecubital region to proximally into the vein. This area was explored with a different incision from the midline of the left arm but catheter was not in the cephalic vein. After taking a new chest graphy of the patient in his bed, it was seen that the broken part of the catheter had

been located in the axillary vein (Picture 2a and 2b).

Picture 2a: A view of the broken Cava-fix catheter on posteroanterior chest radiography

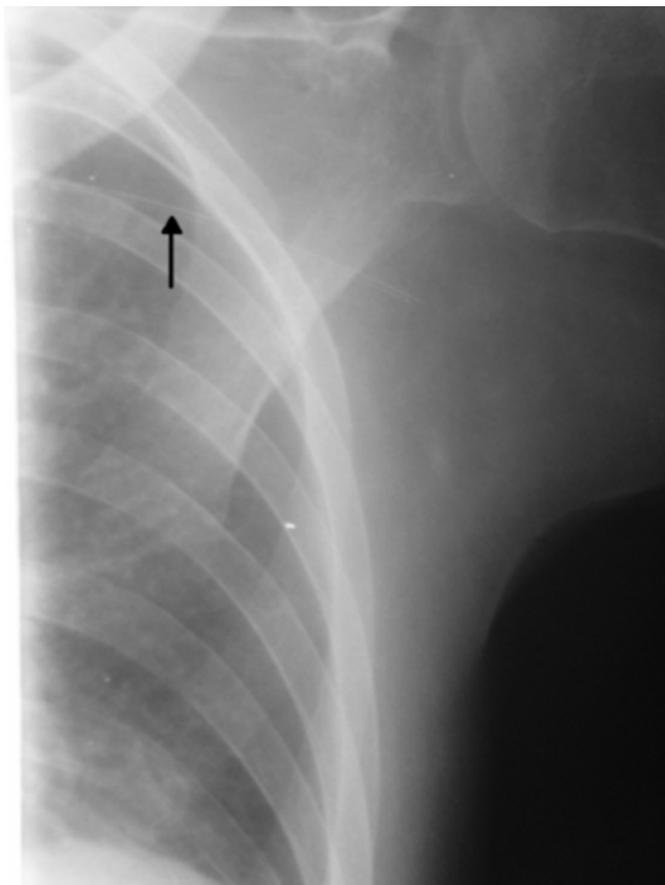
Figure 3

Picture 2b: A view of the broken Cava-fix catheter on posteroanterior chest radiography

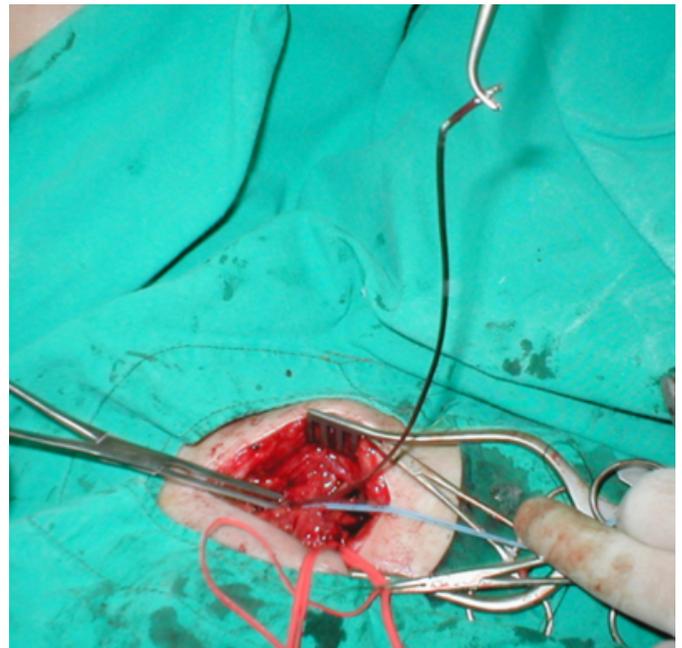
Figure 4

Picture 3a: Taking out of the catheter with the help of a clamp

After that, with the local anesthesia to the left subclavian area, subclavian vein was found with a different incision and

the catheter was found within the subclavian vein when the subclavian vein was turned and hanged. Then transverse venotomy was performed to subclavian vein. The catheter with the surrounding fresh thrombus material was taken out with the help of a clamp from the vein(Picture 3a and 3b). Following that, the venotomy made to subclavian vein was mended by with polypropilen suture and the incision was routinely closed.

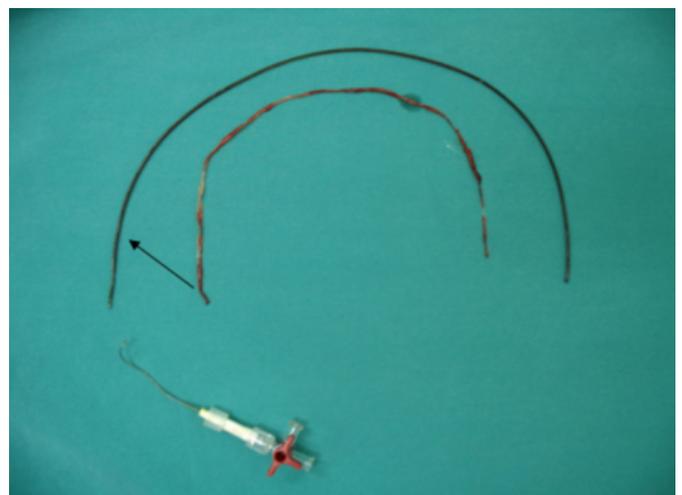
Figure 5

Picture 3b: Parts of Cava-fix catheter and cover thrombus surrounding it (inside)

however the catheter was not be able to found it the located area shown on the diagraphy. Then taking a new diagraphy, we detected the location of the catheter. The catheter which is expected to move so fast in lumen had moved too slowly and it remained there by holding on the vessel wall in the subclavian area. When the catheter was taken out from its location, it was seen that the major factor for the situation was the fresh thrombus material surrounding it (Picture 3b).
