Sheared Epidural Catheter: A Factory Defect

O Akitoye, C Enuh. *Sheared Epidural Catheter: A Factory Defect*. The Internet Journal of Anesthesiology. 2018 Volume 37 Number 1.

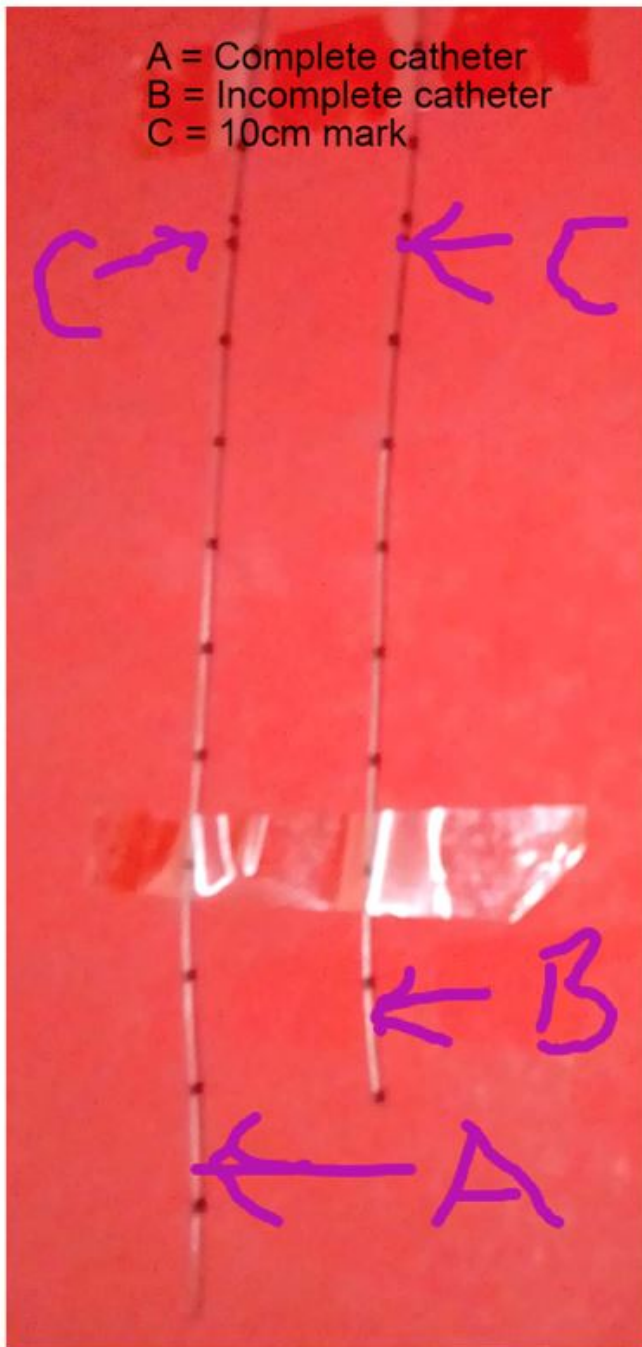
Figure 1

A 65-year-old woman was scheduled to have total abdominal hysterectomy (TAH) due to cervical intraepithelial neoplasia type II. She was counselled for combined-spinal epidural. While in the operating theatre, in the process of checking for the patency of the epidural catheter, it was discovered that the catheter was not complete. It was 2cm short on counting to the 10cm marking on the catheter (Fig. 1). The pack was abandoned and the procedure was carried out using another pack with a complete catheter.

Anaesthetists, most often, check for patency for the catheter but not actually paying attention to the completeness of the catheter as it is assumed to be complete. This report underscores the importance of proper checking of epidural catheter for completeness bearing in mind the medicolegal issues involved, the uncertainty in the localisation of the broken parts, and the controversy surrounding the management of this rare complication.
