Metallosis in an apparently well fixed total knee replacement

P Mukherjee, M Ashworth

P Mukherjee, M Ashworth. *Metallosis in an apparently well fixed total knee replacement*. The Internet Journal of Orthopedic Surgery. 2007 Volume 9 Number 1.

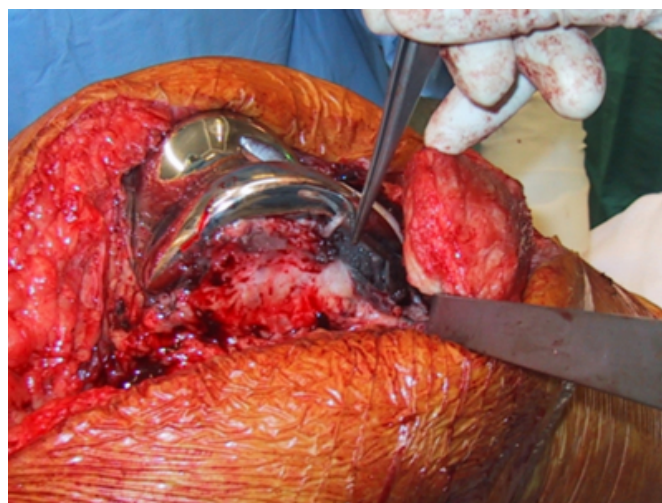
Figure 1

Because of ongoing pain, the decision to explore the total joint replacement with possibility of revision was made. At exploration of the total knee replacement signs of metallosis were found adjacent to both the femoral and tibial components (Fig.1 & 2).

There were no obvious signs of loosening (bubble test was negative). Although the components appear well fixed the polyethylene was considered compromised by the metal debris and revision was undertaken. The extraction of the prosthesis was very easy and there was deficient cementation in a quadrant on each component allowing macro motion and with metallosis formed in these areas, we interpreted this as indicating the joint replacement was loose. The tissue samples taken for microbiology did not grow any micro organisms. The histological examinations of the tissue samples did show signs of metal in the synovium but no polymorphs were seen⁴. Following the revision surgery
