Metallosis in an apparently well fixed total knee replacement

P Mukherjee, M Ashworth. *Metallosis in an apparently well fixed total knee replacement*. The Internet Journal of Orthopedic Surgery. 2007 Volume 9 Number 1.

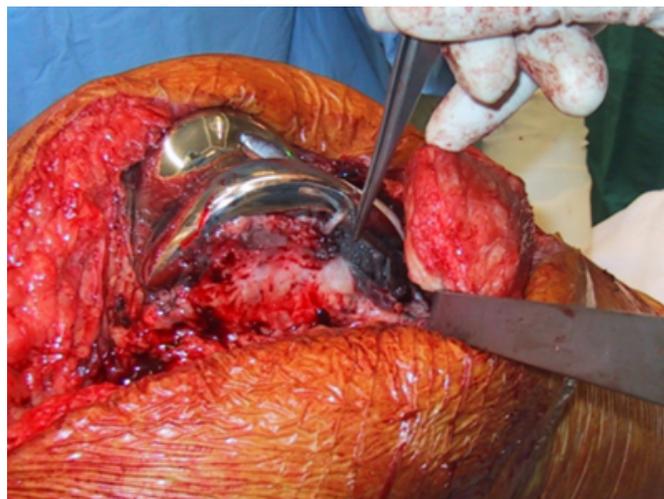
Figure 1

Because of ongoing pain, the decision to explore the total joint replacement with possibility of revision was made. At exploration of the total knee replacement signs of metallosis were found adjacent to both the femoral and tibial components (Fig.1 & 2).

There were no obvious signs of loosening (bubble test was negative). Although the components appear well fixed the polyethylene was considered compromised by the metal debris and revision was undertaken. The extraction of the prosthesis was very easy and there was deficient cementation in a quadrant on each component allowing macro motion and with metallosis formed in these areas, we interpreted this as indicating the joint replacement was loose. The tissue samples taken for microbiology did not grow any micro organisms. The histological examinations of the tissue samples did show signs of metal in the synovium but no polymorphs were seen⁴. Following the revision surgery
