Contaminated Handkerchief Artifact on I-131 Whole Body Scan

B Wosnitzer, R Gadiraju, G Depuey. *Contaminated Handkerchief Artifact on I-131 Whole Body Scan*. The Internet Journal of Nuclear Medicine. 2009 Volume 5 Number 2.

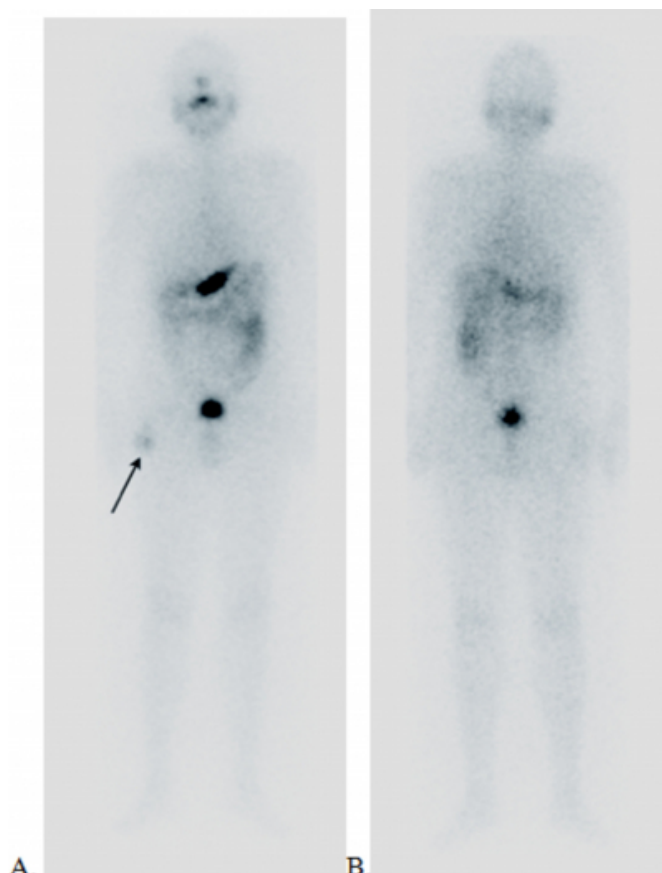
Figure 1 (A&B): 66 year-old male with history of thyroid carcinoma, status post thyroidectomy, and status post radioactive iodine ablation presents for whole body iodine scan to evaluate possible recurrence or metastases. The

patient received two 0.9 mg intramuscular Thyrogen injections on two consecutive days and a 4 mCi I-131 capsule on the third day. Anterior (left) and posterior (right) whole body planar images were obtained 48 hours after capsule administration. Images show no focal abnormal uptake in the neck area to suggest local recurrence. The 48 hour uptake in the neck was 0.2%. Tracer uptake is physiologic in the chest, abdomen, and pelvis. There is a focus of increased tracer uptake in the region inferior to the greater trochanter of the right femur appreciated best in the anterior view (see black arrow).

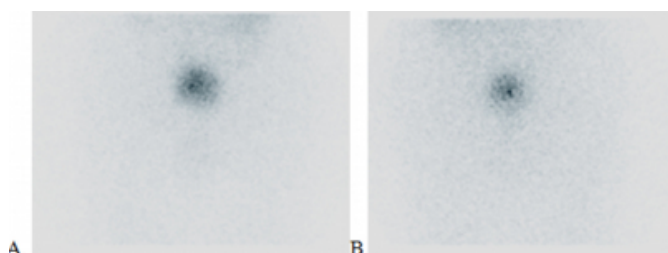
Figure 2 (A&B): Anterior (left) and posterior (right) planar images of the pelvis were acquired after removing a handkerchief from the patient's pocket. Since I-131 is present in nasal secretions, the possibility of contamination artifacts from patients' accessories should always be considered when interpreting "hot spots" on whole body I-131 scans [1,2,3].
