Deformed Spinal Needle

R Verma, R Dutta, S Dube. *Deformed Spinal Needle*. The Internet Journal of Anesthesiology. 2007 Volume 16 Number 2.

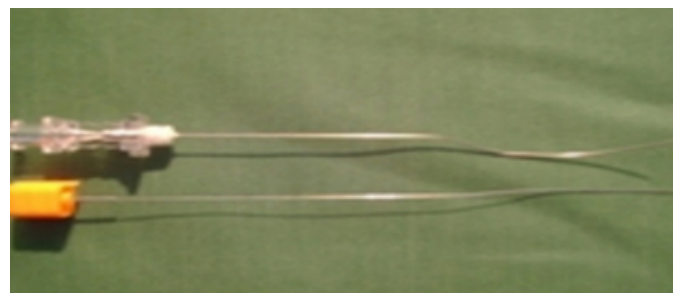
Figure 1

An ASA grade I, 76kg, 152cm, 40year old woman was scheduled for transabdominal hysterectomy. After written and informed consent patient was placed in lateral decubitus position. Under all aseptic precaution and after local infiltration of L2-3 space with 2% lignocaine hydrochloride a 25 gauge Quinke's needle was used to carry out sub-arachnoid block through midline approach. As the needle punctured the interspinous ligament the assistant (who helped the patient to maintain a "knee to forehead position") with an intention to provide facilitation to apply the block provided an extra force. That extra force leads to a sudden marked deformation in the shape of needle (fig.1). Immediately, the needle was withdrawn and any broken segment was ruled out.

positioning the patient⁵. Bone impact and needle redirection are the other well known causes of gross deformations of needle tip. Therefore, we should always explain the procedure not only to the patient but also to the assistant who play an important role in helping the patient to maintain position and should avoid applying force once the spinal needle is in place.
