Sheared Epidural Catheter: A Factory Defect

O Akitoye, C Enuh. *Sheared Epidural Catheter: A Factory Defect*. The Internet Journal of Anesthesiology. 2018 Volume 37 Number 1.

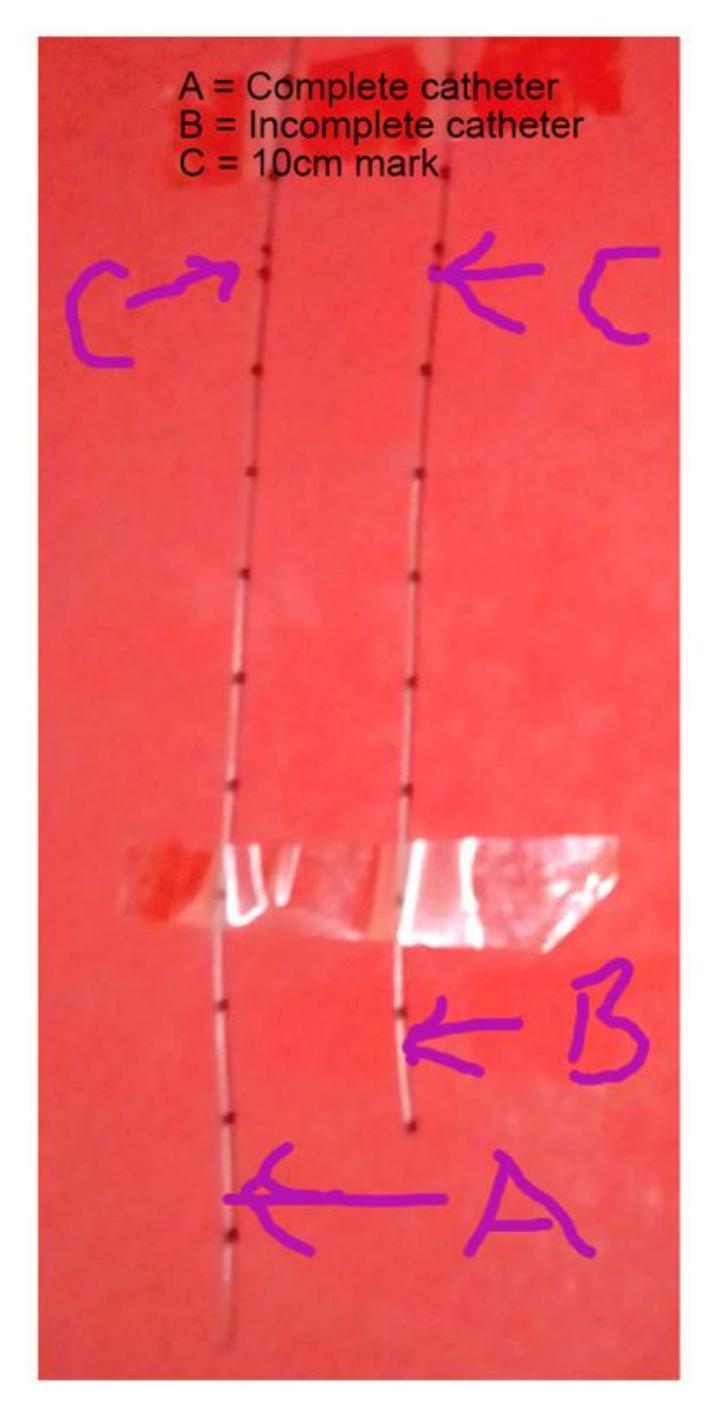
Figure 1

A 65-year-old woman was scheduled to have total abdominal hysterectomy (TAH) due to cervical intraepithelial neoplasia type II. She was counselled for combined-spinal epidural. While in the operating theatre, in the process of checking for the patency of the epidural catheter, it was discovered that the catheter was not complete. It was 2cm short on counting to the 10cm marking on the catheter (Fig. 1). The pack was abandoned and the procedure was carried out using another pack with a complete catheter.

Some studies have advised the checking of the epidural catheter for manufacturer's error which can make the catheter to be easily broken during insertion or removal.[13] Anaesthestists, most often, check for patency for the catheter but not actually paying attention to the completeness of the catheter as it is assumed to be complete. This report underscores the importance of proper checking of epidural catheter for completeness bearing in mind the medicolegal issues involved, the uncertainty in the localisation of the broken parts, and the controversy surrounding the management of this rare complication.
