Bluish Discoloration of the Arm after Implantable Cardioverter Defibrillator Implantation

R Khouzam, R Vrushab. *Bluish Discoloration of the Arm after Implantable Cardioverter Defibrillator Implantation*. The Internet Journal of Cardiology. 2006 Volume 4 Number 1.

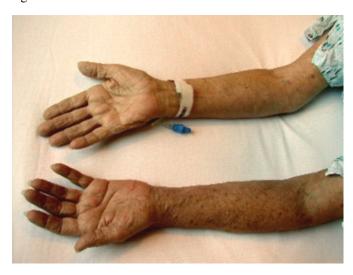
Figure 1

A 75 year old female with history of dilated cardiomyopathy, left bundle branch block and an ejection fraction of 25 %.underwent an ICD device implantation in the left pectoral area through the axillary vein approach, for primary prevention of sudden cardiac death. Ten days later, she presented with mottling of the skin and bluish discoloration and numbness of the left upper extremity from the arm down to the hand, manifested mostly after she takes a shower (Fig. 1). A Doppler ultrasound revealed the presence of acute deep venous thrombosis (DVT) of the left upper extremity at the level of the subclavian and axillary veins. Anticoagulation was initiated and the patient's condition improved.

Figure 1: Patient extending both arms, showing mottling and bluish discoloration of the left arm, compared to the normal right arm.

Pacemakers, ICDs and more recently biventricular pacemakers are considered a safe treatment modality for many cardiac disease entities with recent growing use due to increased indications through appropriate guidelines. Rare but serious thrombotic and embolic complications are reported to occur in 0.6-3.5% of cases (1). Early recognition of this potentially serious disease is important, as prompt treatment needs to be initiated. There are different clinical symptoms and signs that can lead the patient or the physician to the diagnosis, of which arm edema might be the most prominent (2). More subtle signs can be the only clue as discoloration, as presented by a nice picture in our case.
