The Queen Elizabeth Tuck Technique - A Novel Technique For Removal Of A Strangulating Penile Ring.

C Brumfitt, A Jay, C Ooi, V Saren, E Tho, N Parker, M Lloyd, J Miller, D Spernat. *The Queen Elizabeth Tuck Technique - A Novel Technique For Removal Of A Strangulating Penile Ring.*. The Internet Journal of Urology. 2012 Volume 9 Number 3.

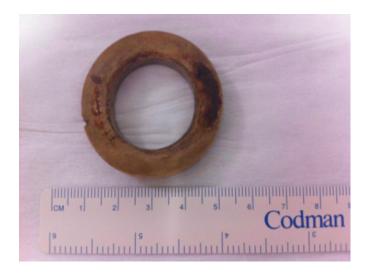
Figure 1

Figure 1. Penile Ring demonstrating overall and internal diameter

discoloured and grossly engorged (approximately 6cm in diameter) penis with a thick metallic device at the base. The metallic ring measured 4cm in diameter with an inner diameter of only 2.5cm (figure 1-3). The skin beneath the device was macerated, presumably from the multiple attempts at removal. The patient reported voiding the previous evening and was not in urinary retention. The Emergency Department Physicians attempted to reduce the penile swelling by application of ice, sugar and compression with minimal results.

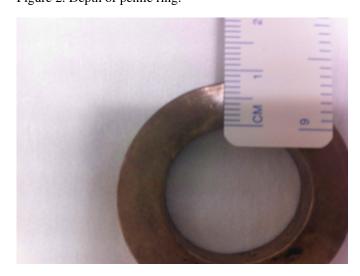
Figure 2 Figure 2. Depth of penile ring.

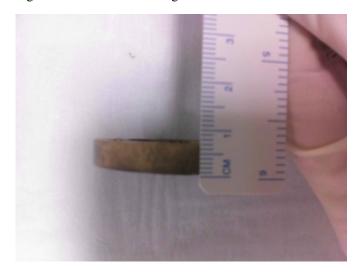
Figure 3 Figure 3. Width of Penile ring.
