# Migration Of Left IJV Catheter Into Pleural Space

S Dave, S Mahapatro, L Dewoolkar. *Migration Of Left IJV Catheter Into Pleural Space*. The Internet Journal of Anesthesiology. 2006 Volume 12 Number 1.

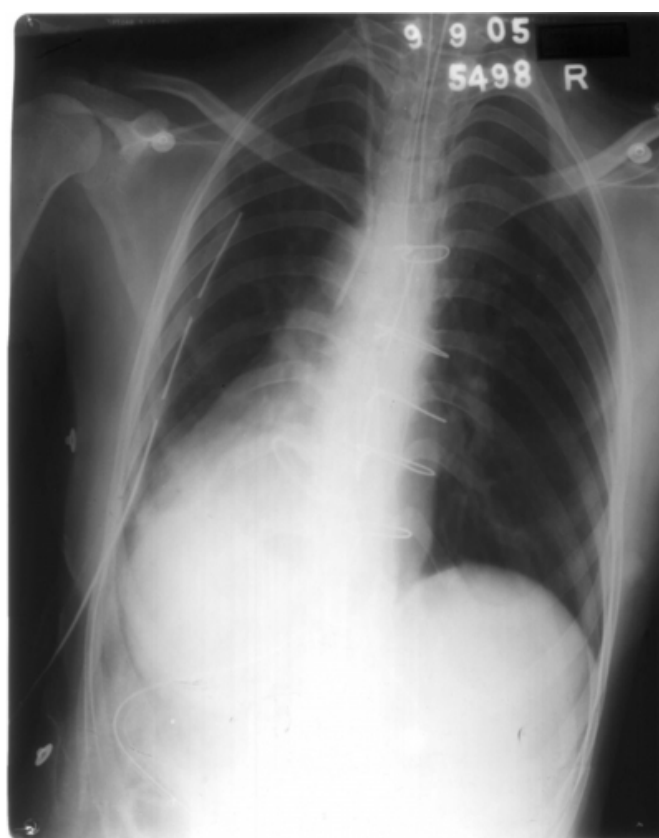
## Figure 1

At closure a bulge was seen in the left pleura and an intercoastal drain was placed. The patient was transferred post-operatively to the intensive care unit and put on a ventilator as part of the protocol. It was noticed that blood products going through IJV appeared to be coming out through the ICD. All fluids were stopped through the IJV and given through a peripheral line. An x-ray chest was suggestive of intra-pleural placement of catheter (photo1).

Figure 1: Photo: X-ray P-A view of chest showing the migrated tip of catheter.

The aspiration of blood from all ports of triple lumen, as well as the CVP tracing confirmed intravascular placement of catheter; with the possible migration of catheter later on

through a nick made by the straight end of the guide wire. Due to curved course of the left IJV trauma to vessel wall can occur especially when the straight end is used. Haemothorax following IJV cannulation due to subclavian artery trauma is a known complication<sup>1</sup>. There was no accidental arterial puncture during cannulation nor any damage to great vessels revealed on re-exploration.

The triple lumen was removed. In view of a continuing drain output, the patient was explored. No injury was found to the great vessels. 500cc of clots was removed from the pleural cavity and patient shifted to ICU. The patient was extubated the same day and discharged in a week. The patient remained hemodynamically stable through all the above mentioned events.
