Shearing Of Plastic Coating Of Stylet With Armored Tube: A Case Report

A El-Dawlatly, A Thallaj, S Nawaz. *Shearing Of Plastic Coating Of Stylet With Armored Tube: A Case Report*. The Internet Journal of Anesthesiology. 2002 Volume 7 Number 2.

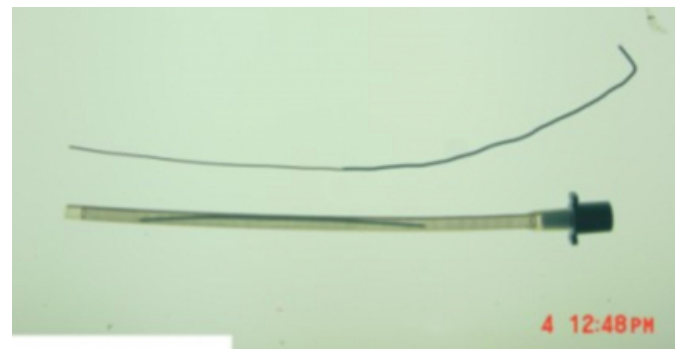
Figure 1:

A 2-yr-old child weighing 8.5 kg was scheduled to undergo craniotomy and excision of a glioma under general anesthesia. Upon arrival of the patient to the operating room, he was connected to routine monitoring and an i.v cannula was inserted. Inhalational induction was accomplished using 2 MAC sevoflurane and 100% oxygen. After the child was adequately anesthetized, atracurium 0.5mg/kg i.v was given to facilitate tracheal intubation. The trachea was intubated easily with a 4.5mm armored ETT (Mallinckrodt, Athlone, Ireland) with the aid of a 6-French plastic-coated stylet (Portex, UK). The stylet was removed with difficulty and it was immediately noted by the attending anesthesiologist that the plastic coating over the distal half of the stylet was missing. The ETT was removed immediately and the trachea was reintubated uneventfully with another ETT. Inspection of the removed ETT showed the sheared plastic coating in the middle portion of the inner-diameter of the ETT. The surgical procedure was performed without further incident.

Above: The stylet with missing of the plastic coating over its distal half Below: The armored ETT showed the sheared plastic coating in the middle portion of its inner-diameter

Stylets are used to shape pediatric ETT to facilitate tracheal intubation. Shearing of the plastic sheath of the stylet leading to ETT obstruction has been reported with smaller tubes (4). It has been suggested that this happens due to the tight-fitting stylet with a pliable coating and a firm grasp of the ETT over the stylet. In a previous case report shearing of plastic coating of stylet with double-lumen tube was reported in an adult (5). It was suggested that, shearing of the plastic coating of the stylet usually occurs at the point where it is angulated to assist intubation.

occurred with a 4.5mm ETT despite the use of plastic ETT connector. In smaller tubes the friction between the ETT and the plastic sheath of the stylet is dominant. Obviously, in our incident, the frictional force of the armored ETT was greater than the tensile strength of the sheath, therefore shearing occurs. To the best of our knowledge, this is the first report of shearing of the plastic-coated stylet occurring with an armored ETT. We believe that endotracheal tube stylets should be inspected after each use.
